TESTING AND ASSESSMENT OF CG-7 PRESSURE RELIEF VALVE AND PROPANE CYLINDER PERFORMANCE

VOLUME 1: RESULTS AND EVALUATION

January 31, 2003

BATTELLE
505 King Avenue
Columbus, Ohio 43201-2693

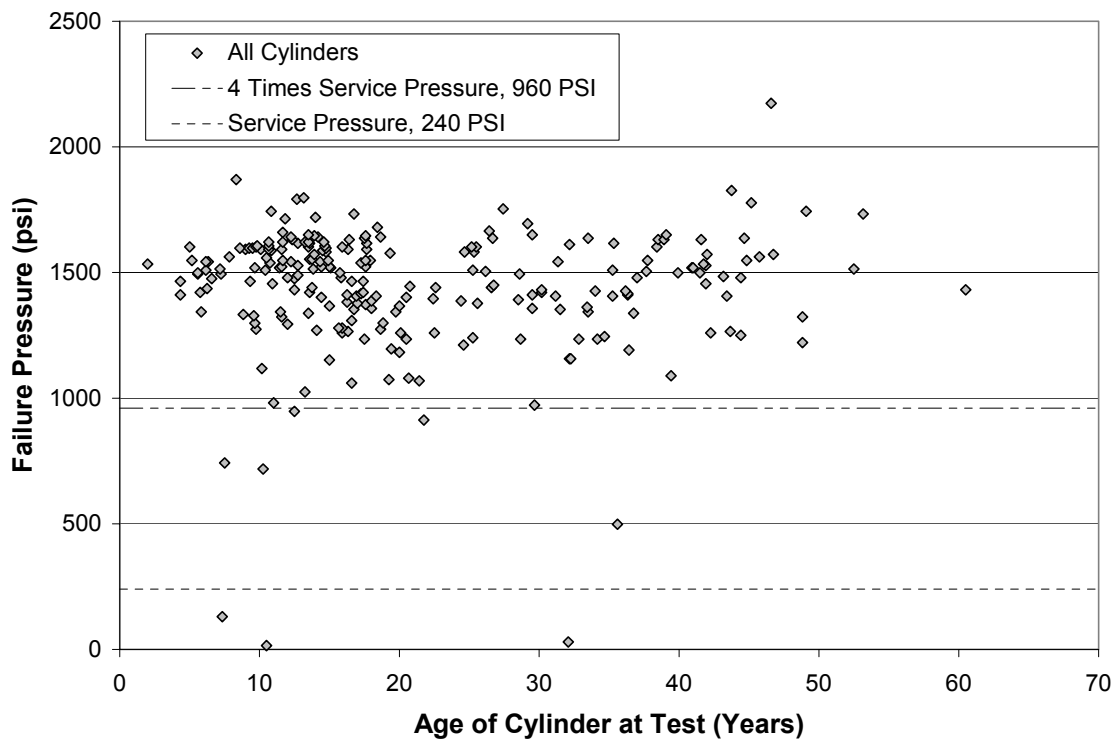
Performance and integrity of the propane cylinders were established by burst testing each of the 236 test cylinders. The minimum design burst pressure criterion used here is 960 psi, or four times the service pressure of 240 psi, consistent with typical DOT requirements. The measured burst pressures were compared to predictions by visual inspection and hydrostatic expansion test to determine how well they predicted low failure pressure performance and how conservative their predictions were. Visual inspection predicts integrity based upon visual appearance of excessive corrosion or damage. Although visual inspection predicted failure (rejected), 196 out of 236 cylinders (83.1 percent), only 8 of 236

cylinders tested, (3.4 percent) actually failed at pressures below 960 psi. The oldest cylinder tested, 60 years old, failed at 1400 psi. Visual inspection was successful in rejecting each of the 8 cylinders which failed below 960 psi. In fact, the lowest failure pressure of a cylinder that passed visual inspection was 1235 psi, more than five times the service pressure. The test results indicate that these cylinders are durable and robust and that the current visual inspection method is an effective and very conservative criterion for identifying damaged or weakened cylinders.

Figure 13. Failure pressure of all cylinders tested as a function of age.

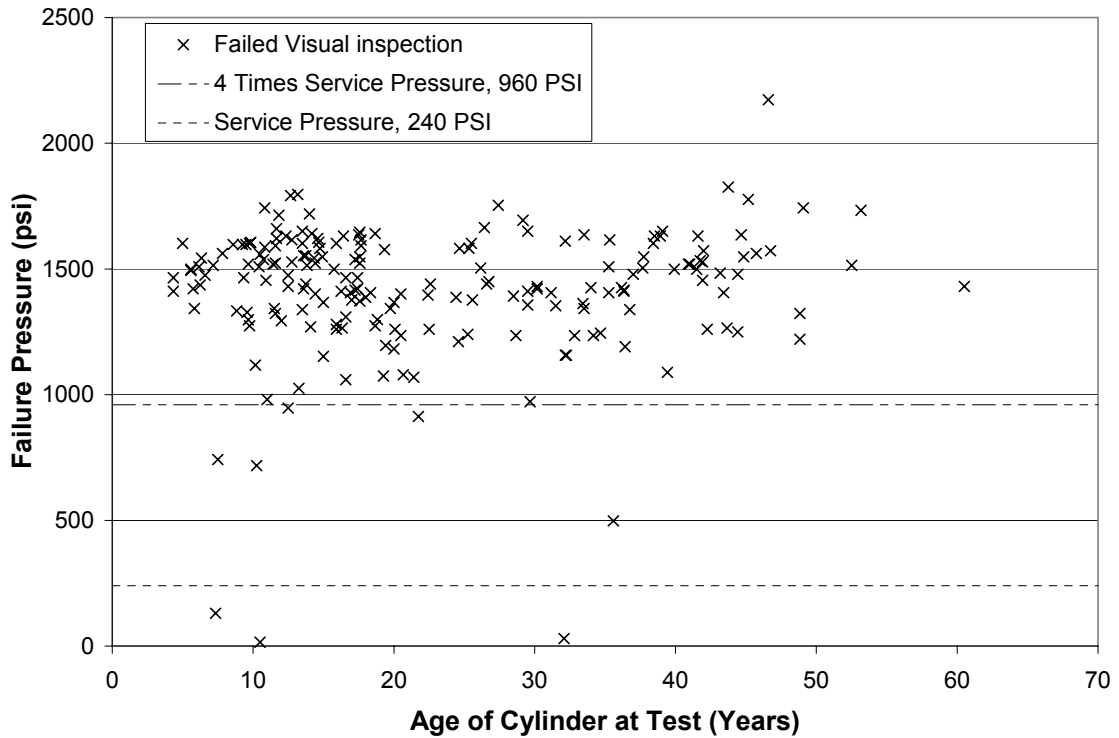
Figure 15. Failure pressure of cylinders that failed visual inspection as a function of age.

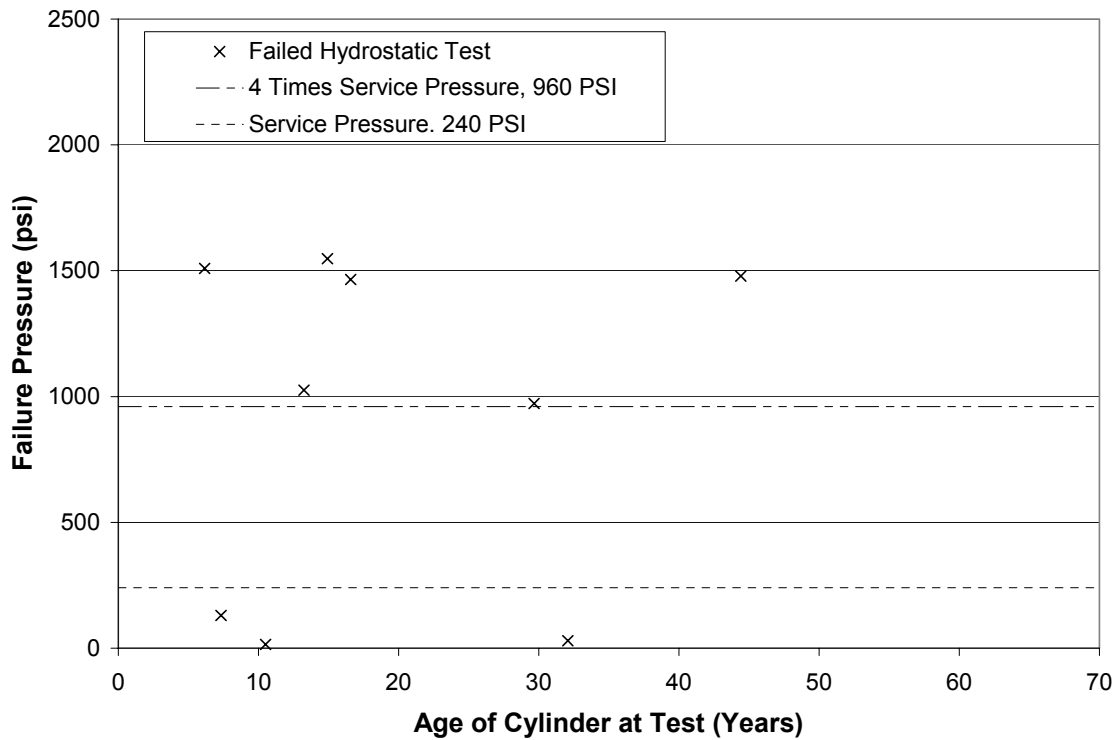
These test results indicate that hydrostatic expansion testing was not effective at identifying weakened cylinders tested in this program. Further examination is warranted. Hydrostatic expansion depends upon steel properties and upon wall thickness. It should be expected to discern the integrity of cylinders that fail by general corrosion over the entire surface. However, the failures observed in this investigation occurred primarily because of localized corrosion or other local phenomena. Hydrostatic expansion with a 10 percent expansion criterion did not appear capable of detecting this type of failure. Figure 21 compares the burst pressure of the tested cylinders to the permanent expansion that was measured. These results suggest that a criterion of 2 or 3 percent maximum permanent expansion might be better able to discern the integrity of cylinders. However, there are other issues that need to be considered before modifying the expansion criterion. The results suggest that this test method should be reviewed to reevaluate its suitability for this class of cylinder.

Figure 20. Failure pressure of cylinders that failed hydrostatic expansion test.

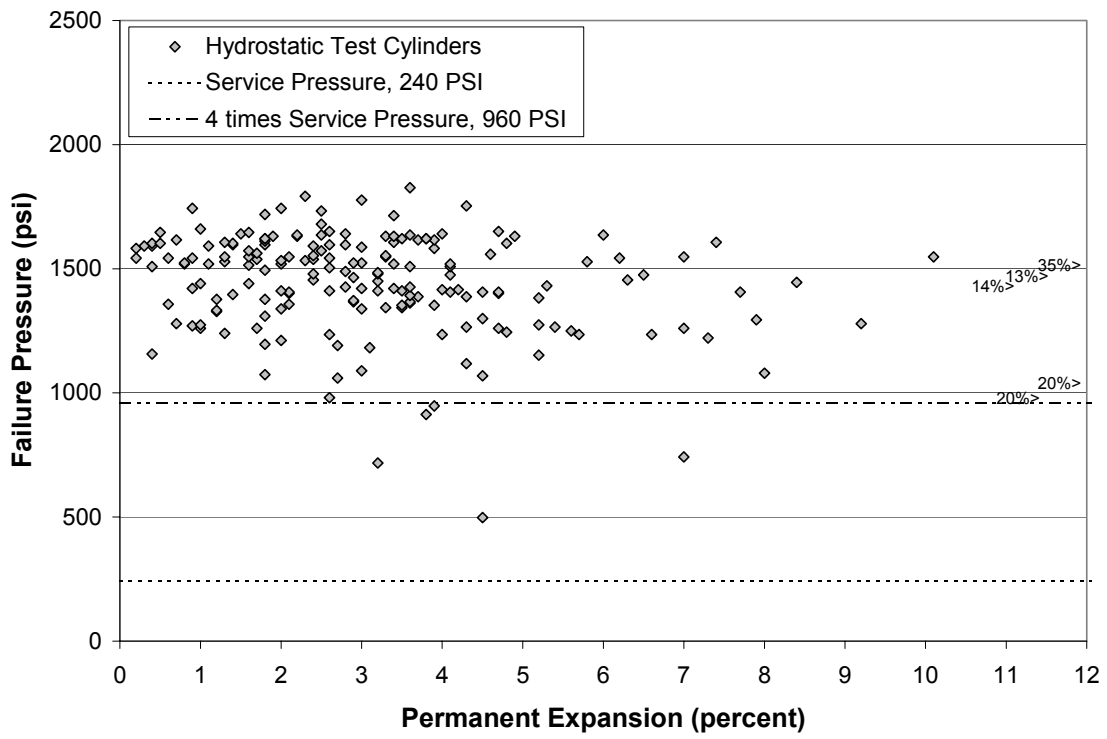
Figure 21. Comparison of cylinder failure pressure to percent permanent expansion measured in hydrostatic test.

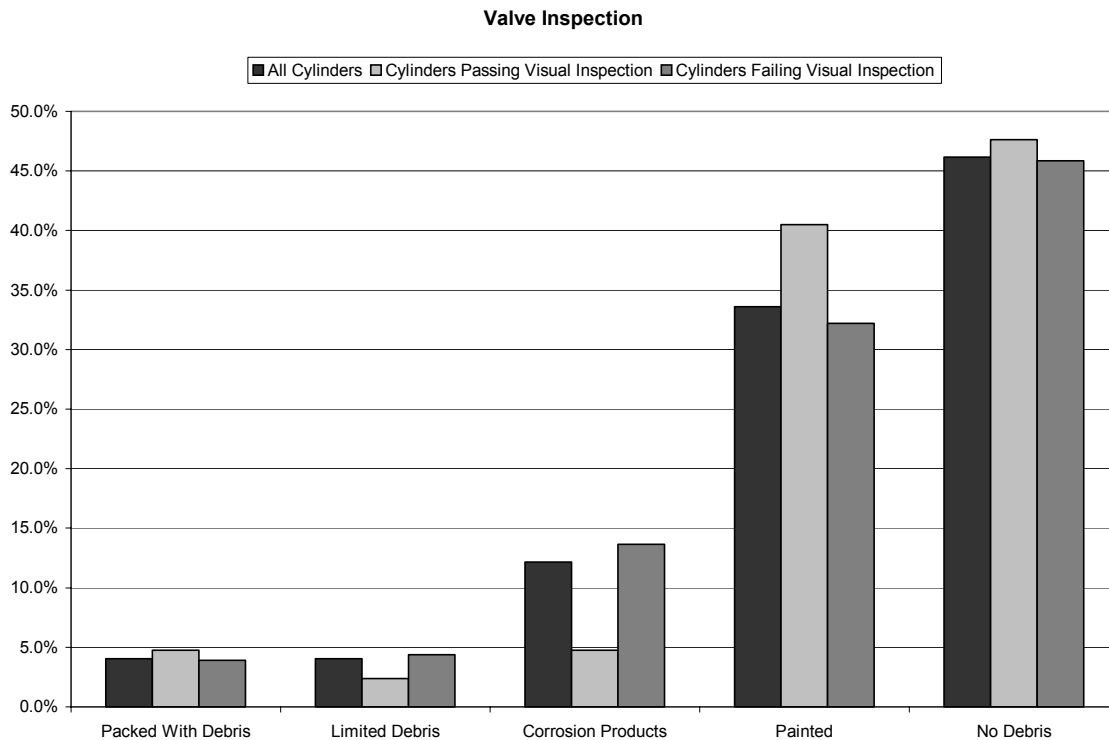
Figure 22 shows the results of the visual inspection of relief valves and compares those from cylinders passing visual inspection to those failing cylinder visual inspection.

Figure 22. Summary and comparison of results of visual inspection of valves from cylinders which passed and failed cylinder visual inspection procedures.
