TESTING AND ASSESSMENT OF CG-7 PRESSURE RELIEF VALVE AND PROPANE CYLINDER PERFORMANCE

VOLUME 1: RESULTS AND EVALUATION

January 31, 2003

BATTELLE
505 King Avenue
Columbus, Ohio 43201-2693

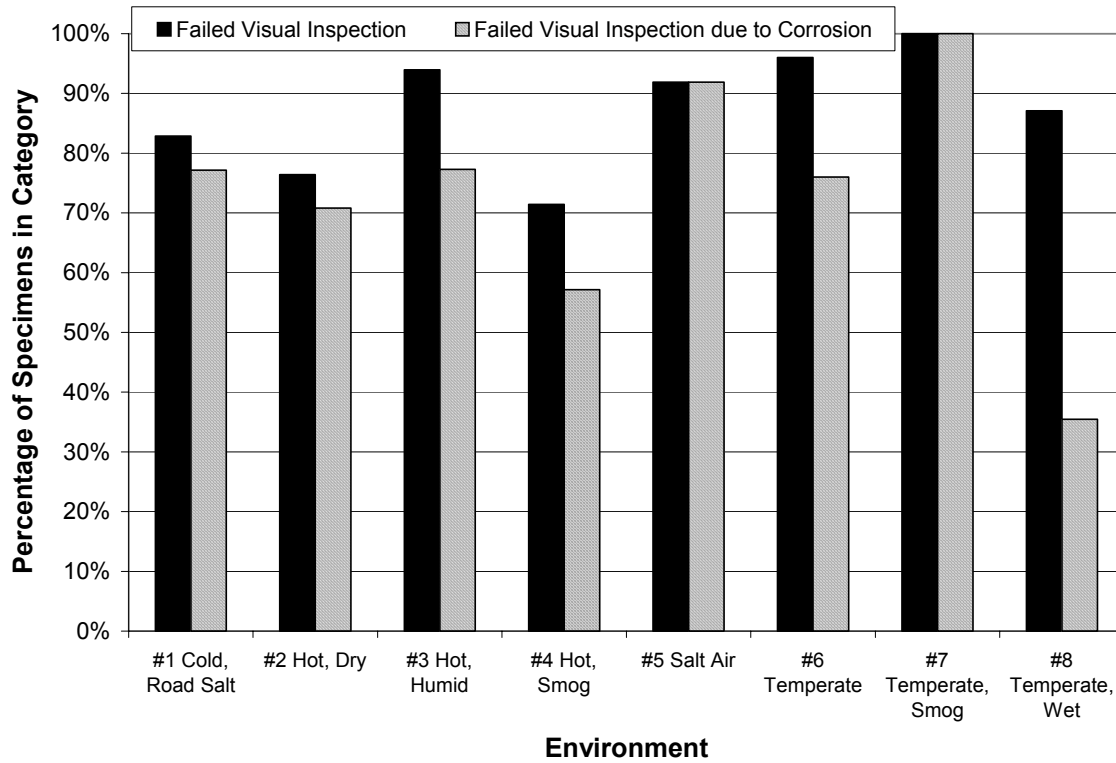
Figure 11 compares the visual inspection results on the basis of the environment where the cylinder was obtained. According to this figure, the percentage of cylinders which failed visual inspection ranged from 71 to 100 percent. The percentage of cylinders failing visual inspection due to corrosion ranged from 35 to 100 percent. Of the eight environments under consideration, it is worthy to note that all of the

Figure 11. Comparison of the percentage of cylinders collected from each source environment which failed visual inspection for all causes and those which failed inspection due to corrosion.

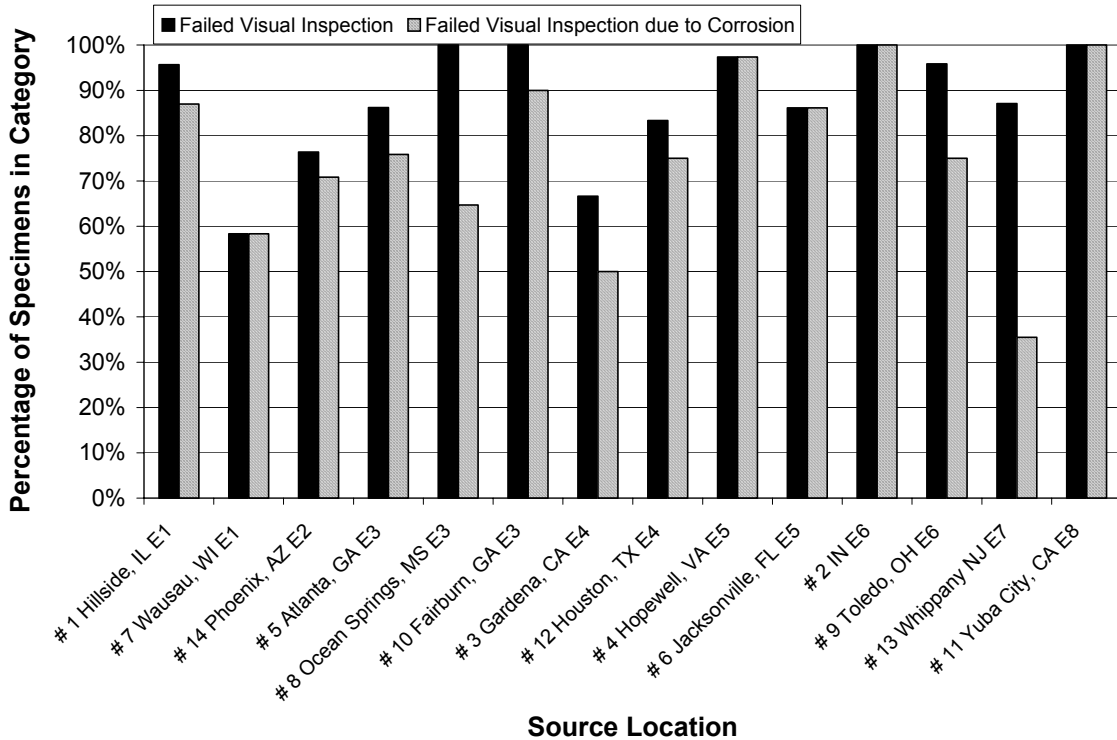
Figure 12. Comparison of the percentage of cylinders collected from each source location which failed visual inspection for all causes and those that failed inspection due to corrosion.

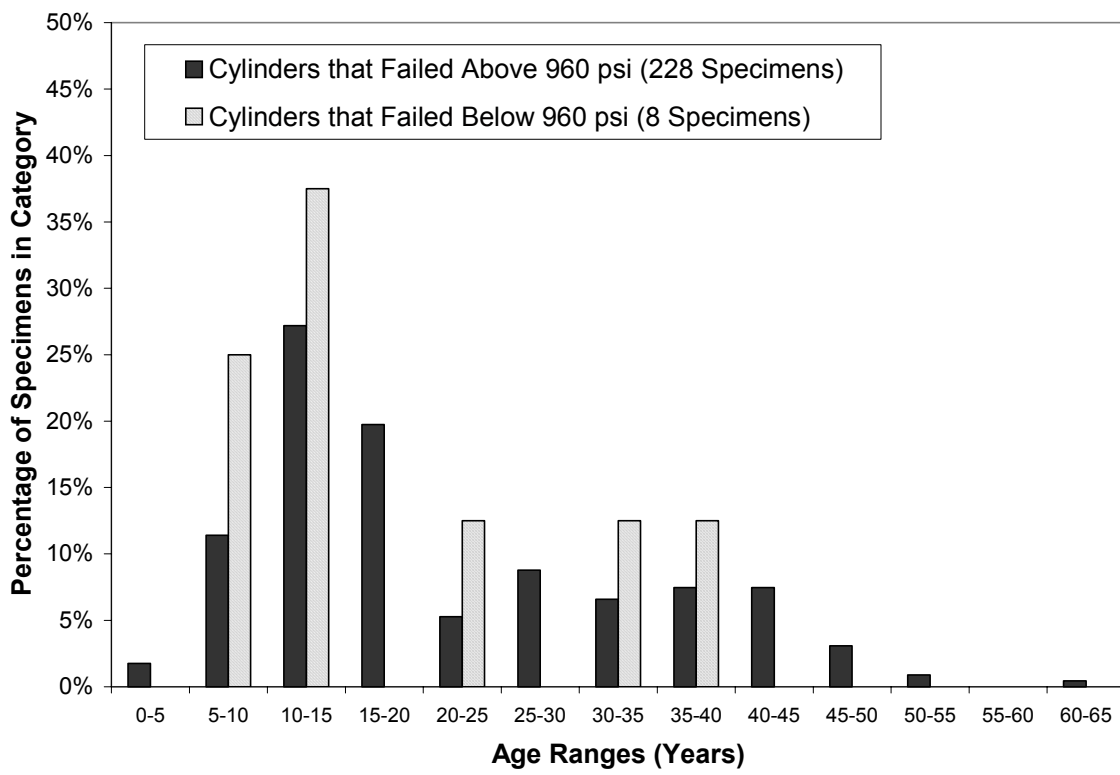
For further examination, Table 2 summarizes the condition of the eight specimens that failed below 960 psi and Figures 16 through 18 compare the burst pressure results on the basis of age, source environment, and source location. The results in Figure 16 show that 25 percent of the cylinders that failed below 960 psi were less than 10 years old and 37.5 percent were between 10 and 15 years old. This suggests cylinders do not degrade continuously with age, but that newer cylinders may be damaged or degraded as much as older cylinders. Figures 17 and 18 indicate that the majority of cylinders that failed below 960 psi were from a single location and environment in Georgia. Table 2 shows that, of the 8 that failed the criterion, 6 were related to corrosion. Five of the 6 failures from the Georgia environment were related to corrosion. The burst test results confirm the visual inspection results that, for this set of propane cylinders, corrosion was the primary cause of degradation.

Figure 16. Comparison of the age distribution of cylinders that failed above and below 960 psi.

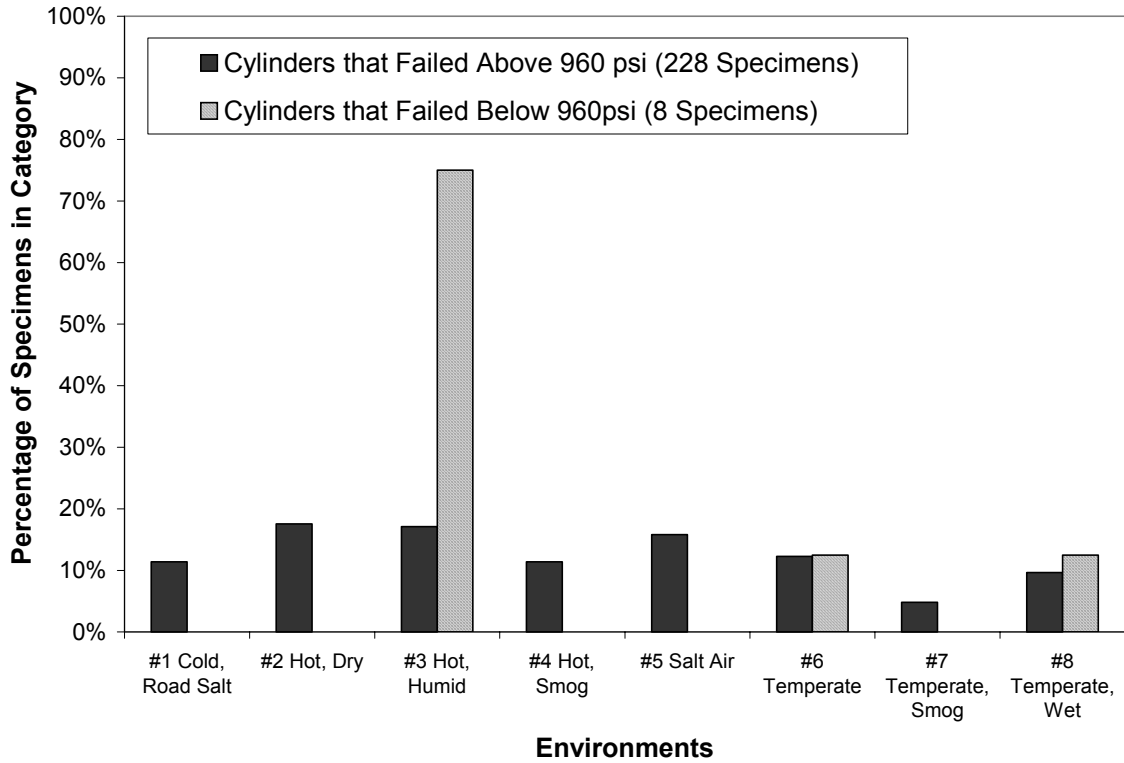
Figure 17. Comparison of the environment distribution of cylinders that failed above and below 960 psi.

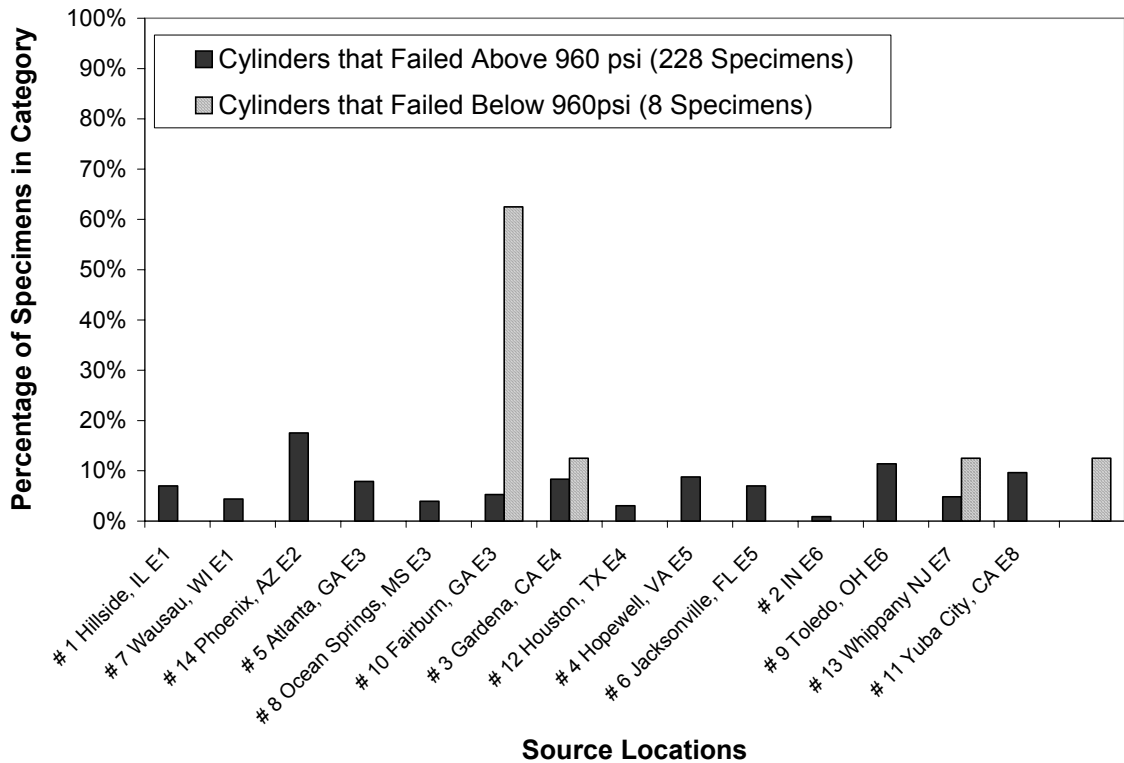
Figure 18. Comparison of the source location distribution of cylinders that failed above and below 960.

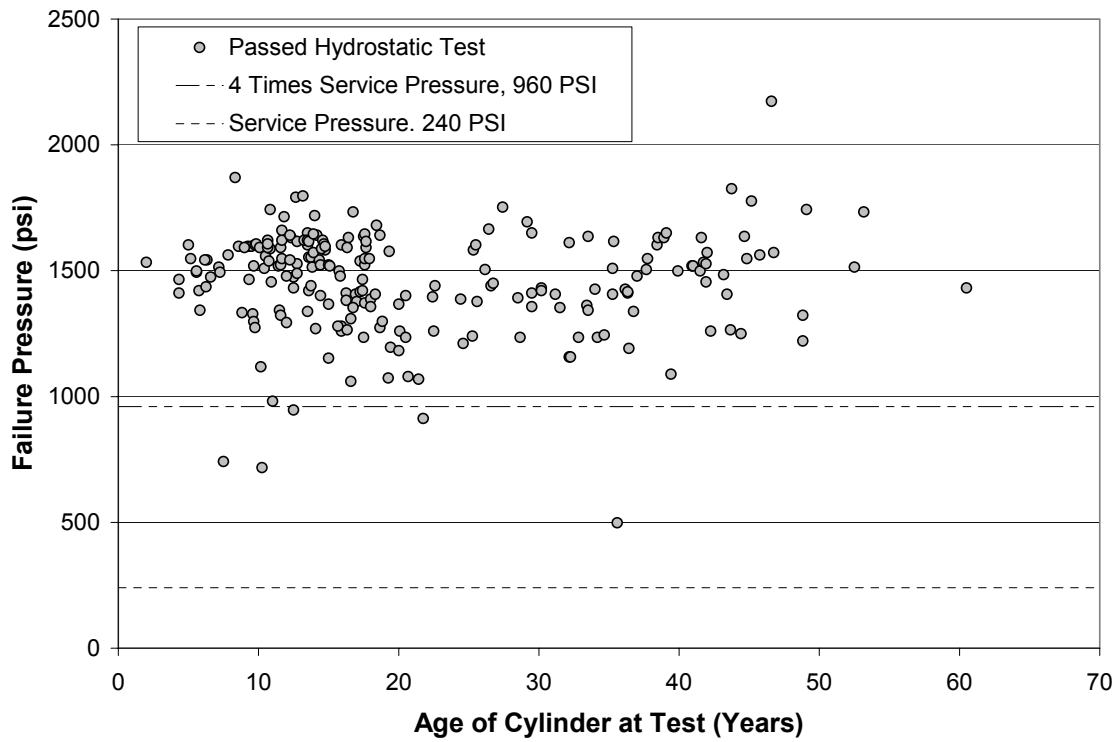
Figure 19 and Table 2 summarize the results for cylinders which passed hydrostatic expansion test. Figure 20 and Table 3 summarize the results for cylinders which failed the hydrostatic expansion test. In examining the results in Figure 19, five specimens which passed the hydrostatic expansion test had failure pressures below 960 psi, meaning they were actually unsatisfactory to remain in service. In examining the results in Figure 20, six specimens that failed the hydrostatic test had failure pressures above 960 psi, meaning they were satisfactory to remain in service.

Figure 19. Failure pressure of cylinders that passed hydrostatic expansion test as a function of age.

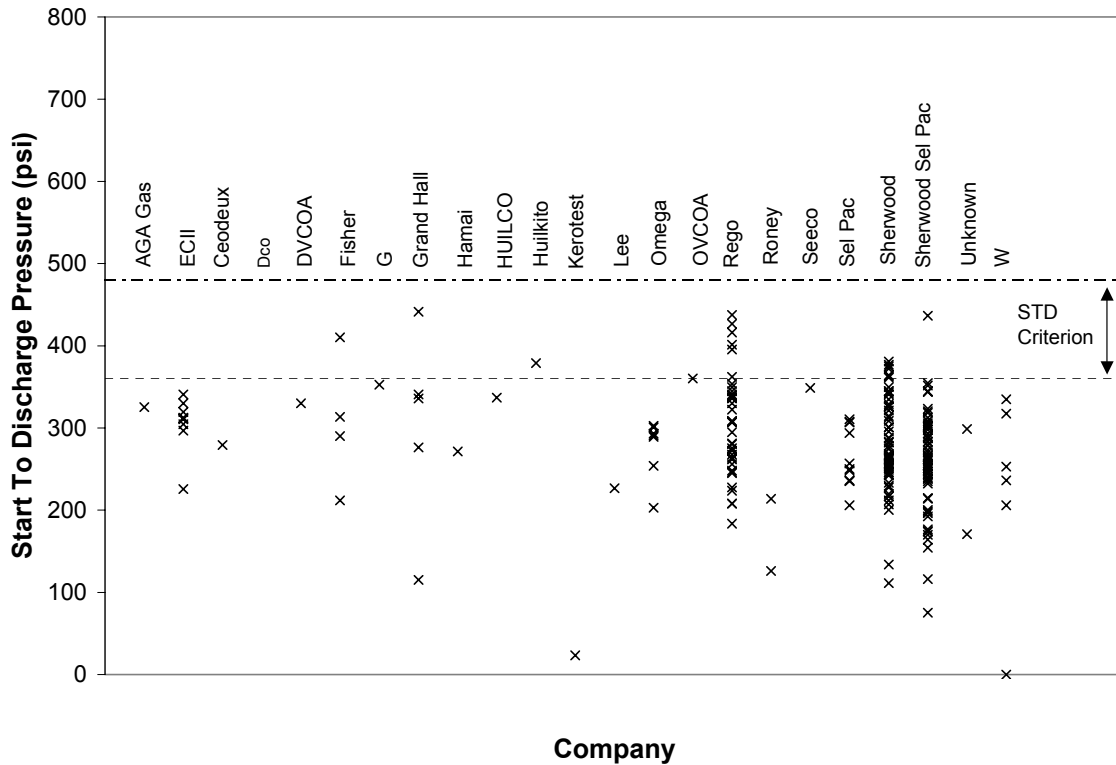
Lastly, the valve manufacturer comparison in Figures 48 through 53 suggests that the manufacturers with the largest number of valves showed the greatest span of results. More Rego, Sherwood and Sherwood Sel Pac valves were tested than the other manufacturers as shown by Figure 9. Roughly 20 percent of the valves tested were from Rego, approximately 30 percent were labeled Sherwood and about 28 percent were labeled Sherwood Sel Pac. Each of these showed similar range of results for start-to-discharge, full open and reseal pressures. While the overall range was similar, more of the Sherwood and Sherwood Sel Pac met the test criteria.

Figure 48. Comparison of the Sequence A start-to-discharge pressure results for different relief valve manufacturers.

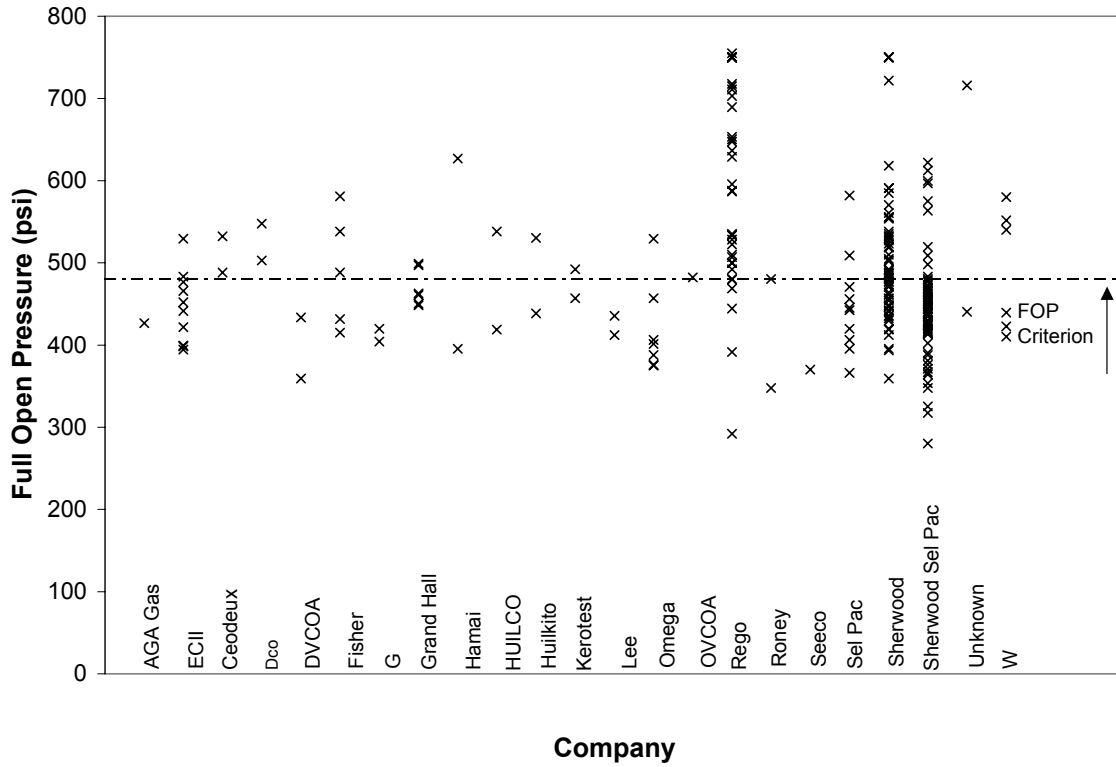
Figure 49. Comparison of the Sequence B start-to-discharge pressure results for different relief valve manufacturers.

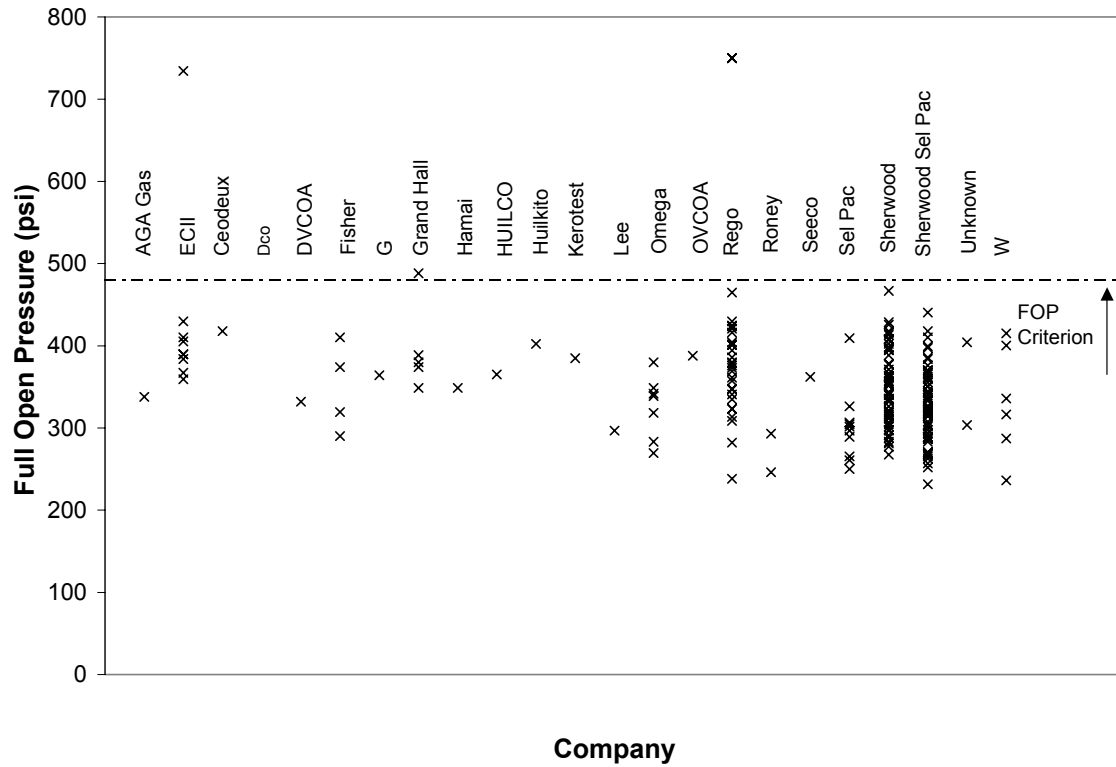
Figure 50. Comparison of the Sequence A full open pressure results for different relief valve manufacturers.

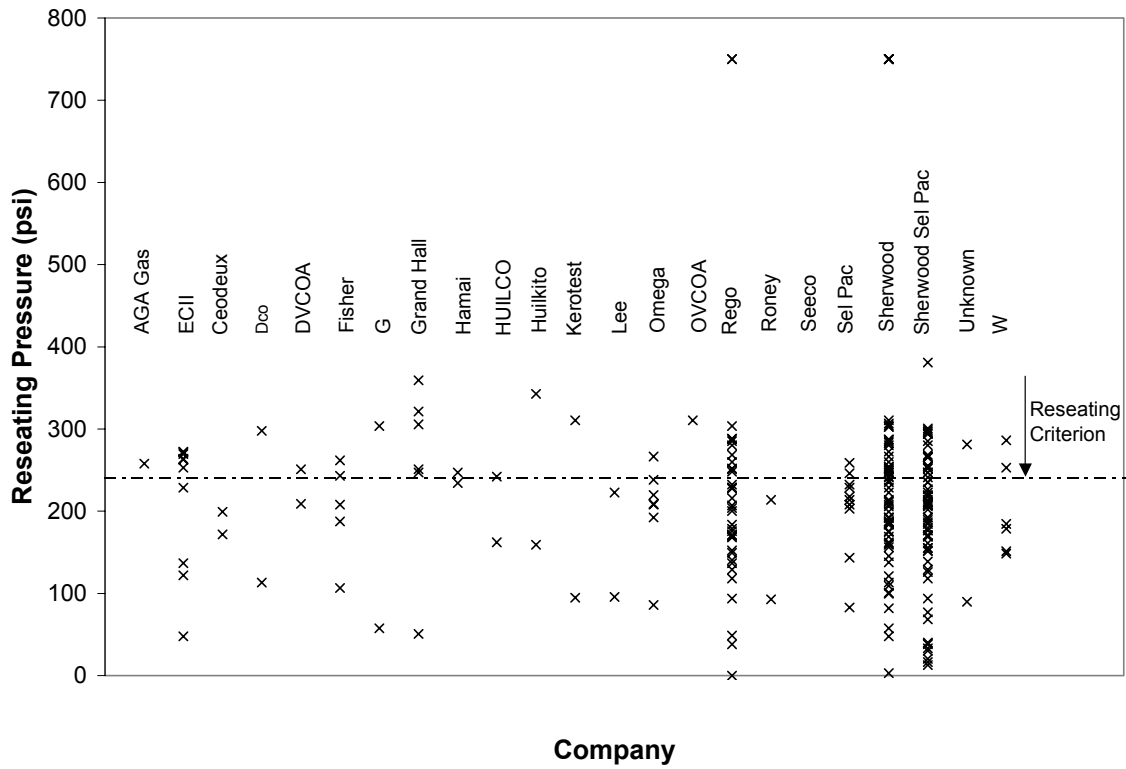
Figure 51. Comparison of the Sequence B full open pressure results for different relief valve manufacturers.

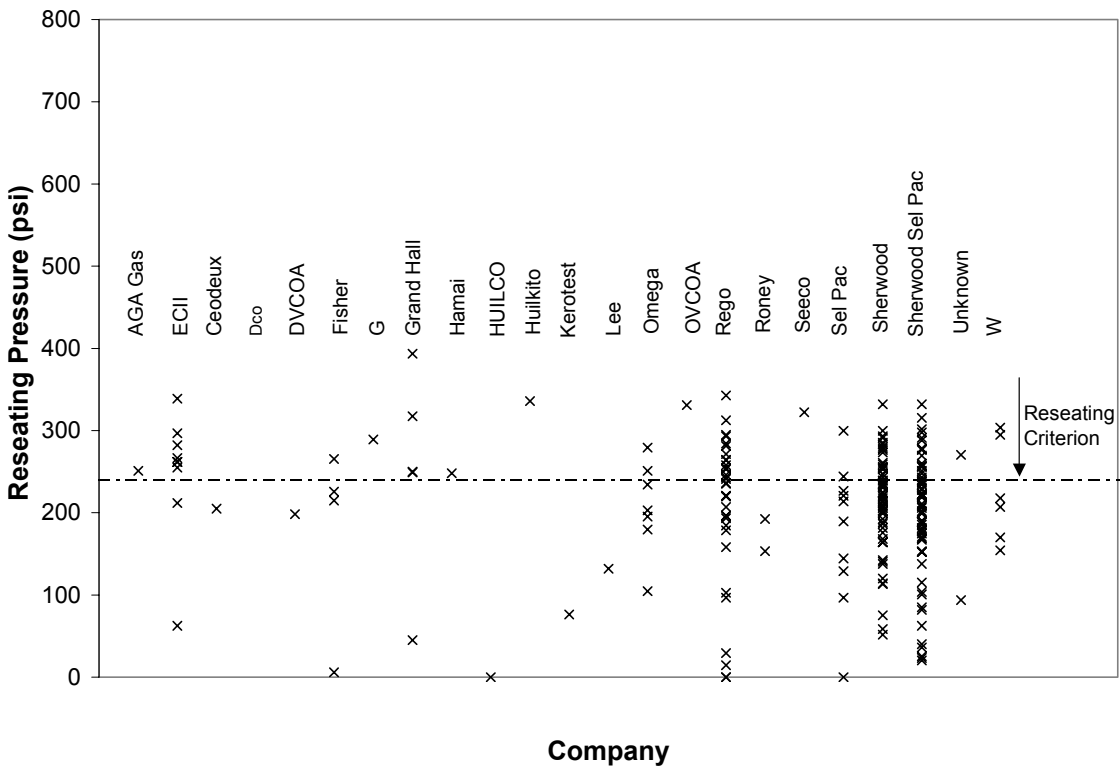
Figure 52. Comparison of the Sequence A reseating pressure results for different relief valve manufacturers.

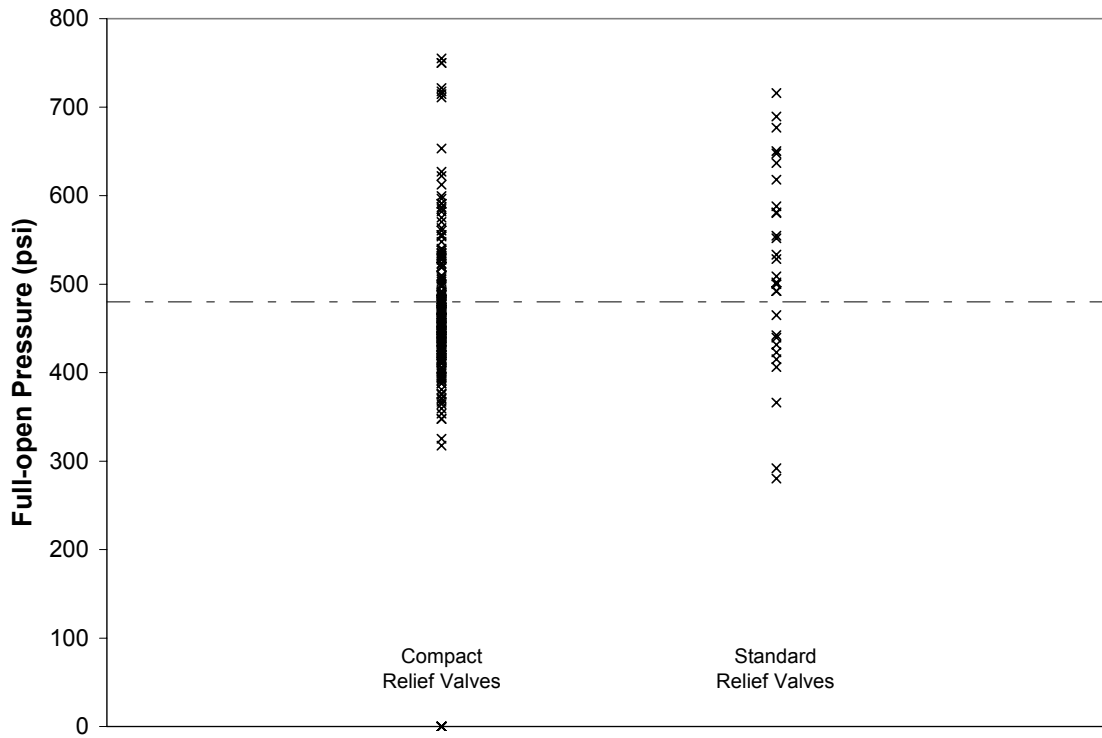
As noted earlier in this report, the majority of relief valves tested were “compact” having a bore diameter of the order of 7/16 inch. Some of the older “standard” relief valves tested had a large bore with a diameter of the order of 5/8 inch. All of the relief valves that opened met the minimum flow rate criterion required by CGA S-1.1. Figures 54 through 59 compare the start-to-discharge, full-open and reseal results for compact and standard relief valves. The data in the figures don’t appear to indicate major distinctions between the performance of the compact and standard valves. Many more compact valves were tested than standard, and, consequently, they appear to have more scatter. However, any apparent differences are more likely the result of the number of each tested than actual differences in performance.

Figure 55. Comparison of the Sequence B start-to-discharge pressure results for compact and standard relief valves.

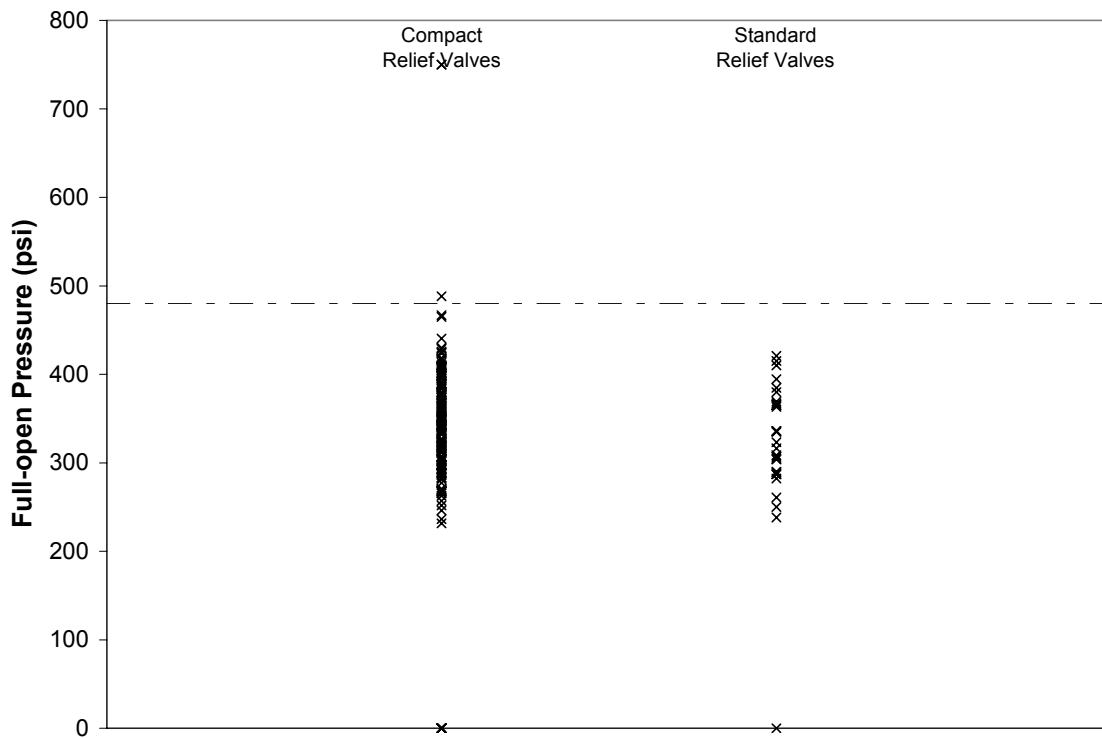
Figure 56. Comparison of the Sequence A full-open pressure results for compact and standard relief valves.

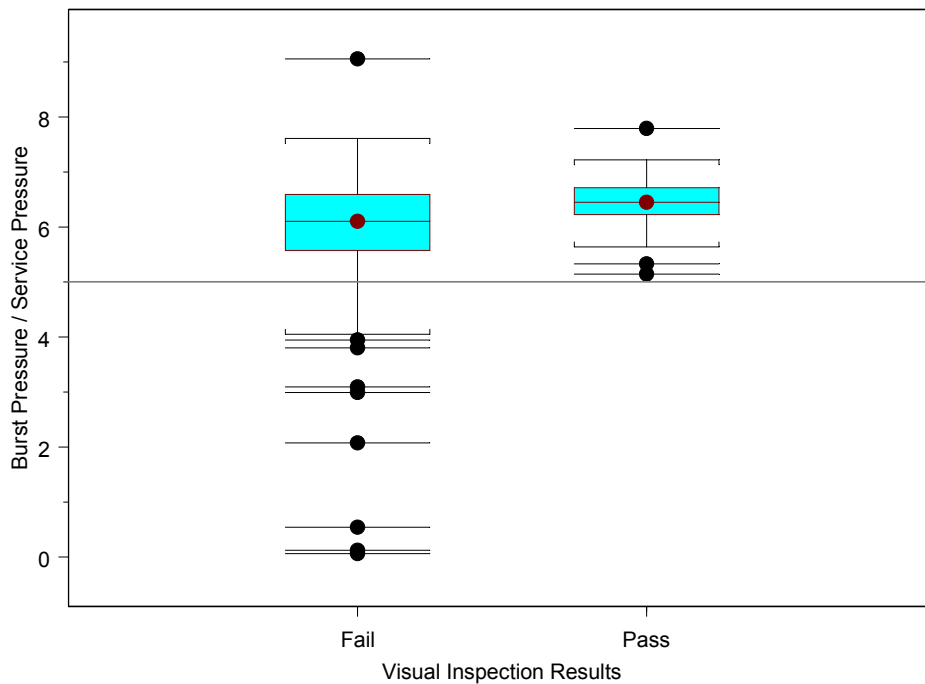
Margin of Safety: Visual Inspection

Failure Pressure / Service Pressure		N	MIN	MAX	MEDIAN	MEAN	STD
Visual Inspection Results	Fail	194	0.06	9.05	6.10	5.92	1.12
	Pass	40	5.15	7.79	6.45	6.44	0.48

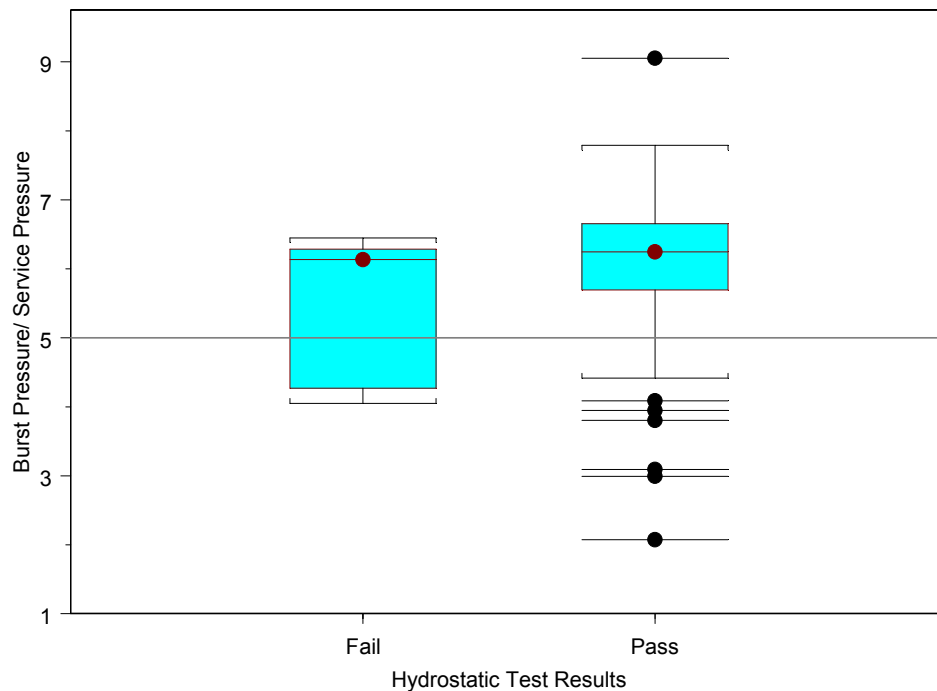
Margin of Safety: Hydrostatic Test

Again, margin of safety is the ratio of failure pressure to service pressure (240 psi). The “typical” or median failure pressure to service pressure ratio for cylinders failing hydrostatic testing is 6.13, while the median of the cylinders passing testing is 6.25.

Failure Pressure / Service Pressure		N	MIN	MAX	MEDIAN	MEAN	STD
Hydrostatic Test Results	Blank	5	0.06	6.59	0.54	2.58	3.23
	Fail	6	4.05	6.45	6.13	5.55	1.09
	Pass	223	2.08	9.05	6.25	6.10	0.82

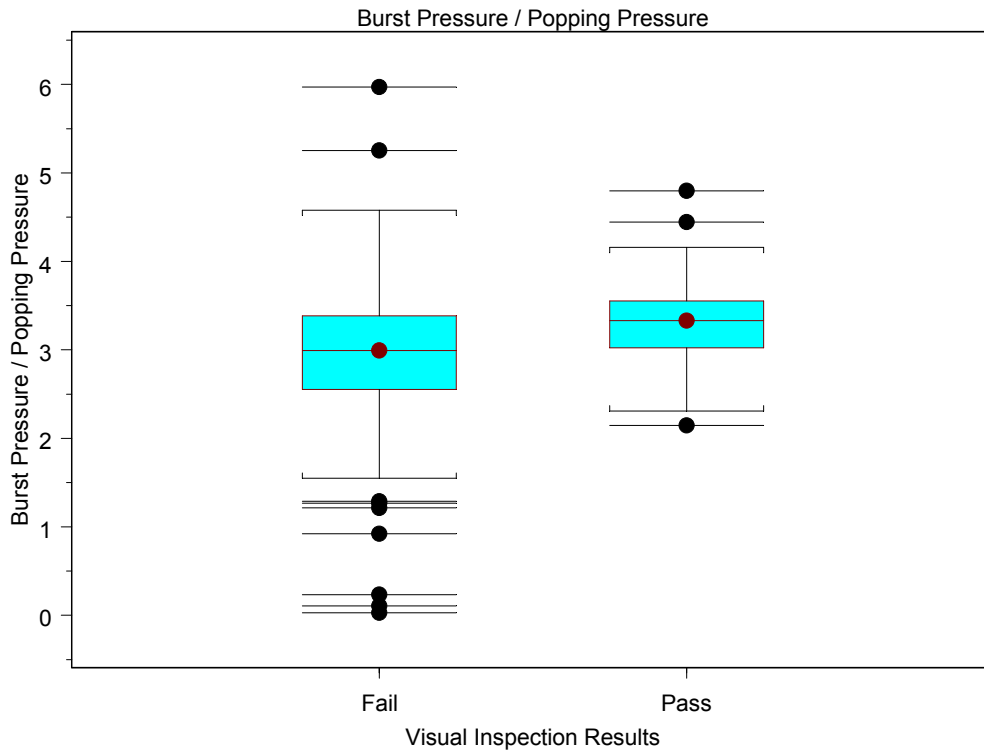
Margin of Safety: Cylinder/Valve Combination

Failure Pressure / Full Open Pressure		N	MIN	MAX	MEDIAN	MEAN	STD
Visual Inspection Results	Fail	181	0.03	5.97	2.99	2.94	0.78
	Pass	33	2.15	4.80	3.33	3.37	0.53

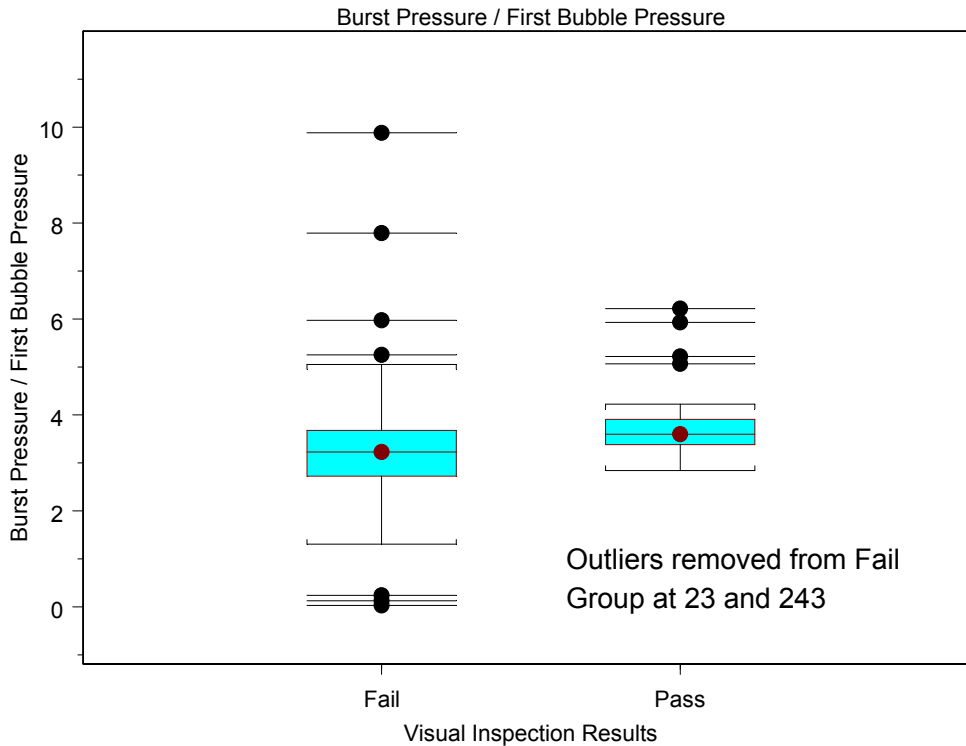
Margin of Safety: Cylinder/Valve Combination

Failure Pressure / Start to discharge Pressure		N	MIN	MAX	MEDIAN	MEAN	STD
Visual Inspection Results	Fail	182	0.03	243.34	3.23	4.65	17.88
	Pass	33	2.84	6.22	3.60	3.78	0.79
